Juneau Airport Wind System (JAWS) Wind Sensor Severe Weather Performance Test Report

August 2002

DOT/FAA/CT-TN02/18

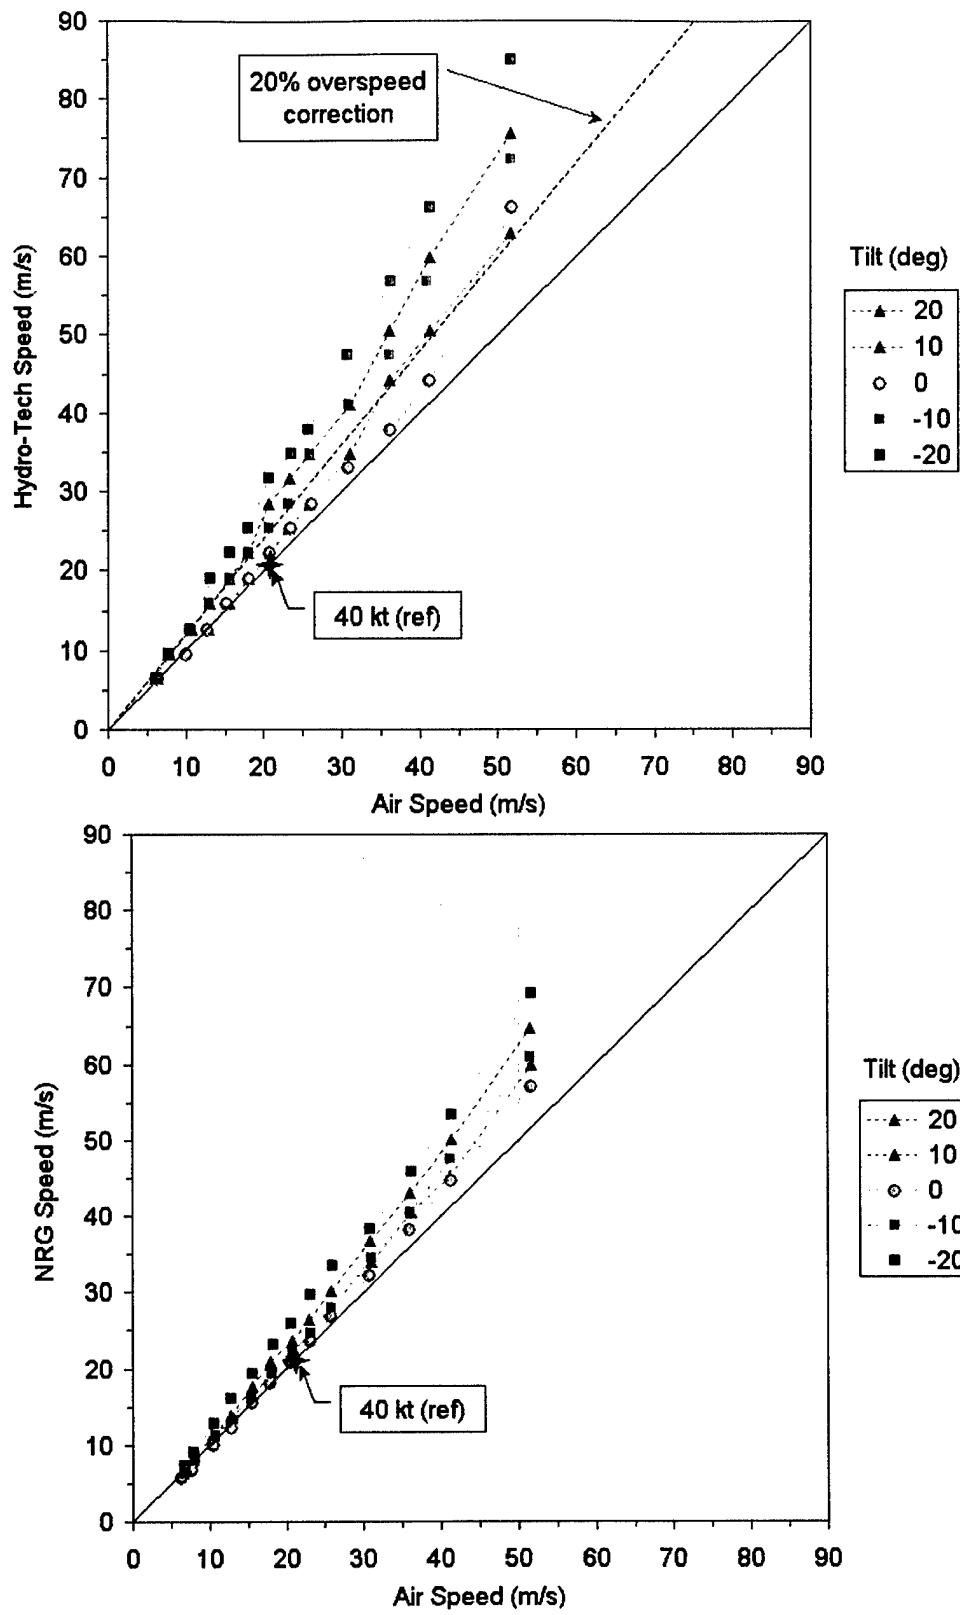
FIGURE 27. WIND TUNNEL ACCURACY RESULTS FOR HYDRO-TECH AND NRG WIND SENSORS

Results of the accuracy tests for the two mechanical sensors are shown in figure 27. The figures show the sensor data plotted against the wind tunnel airspeed for the various tilt angles. The solid diagonal line indicates perfect agreement. For reference, the 20% overspeed correction factor applied to the Hydro-Tech anemometer data (see section 3.2.2.2.1.1) is also indicated in the figure. As previously mentioned, negative tilt angles indicate a wind from beneath the sensor (i.e., sensor tilted from the vertical away from the wind flow). Since the raw wind data was plotted in units of m/s, a wind speed of 40 kt is indicated in the figures for reference.

The results show that both mechanical sensors overestimate wind speed, and the degree of overestimation increases with increasing tunnel wind speed. The Hydro-Tech anemometer errors are greater than the NRG errors. Off-axis winds affect both sensors, with the effects more pronounced for the Hydro-Tech sensor. This observation is consistent with prior wind tunnel test data provided by the manufacturer. The Hydro-Tech data indicates that the 20% overspeed correction factor currently used in the Juneau wind system may be an underestimate. Based on wind tunnel air speeds at 40 kt, the Hydro-Tech sensor overestimates the wind speed by as much as 45% for an upslope wind 20° from the horizontal.

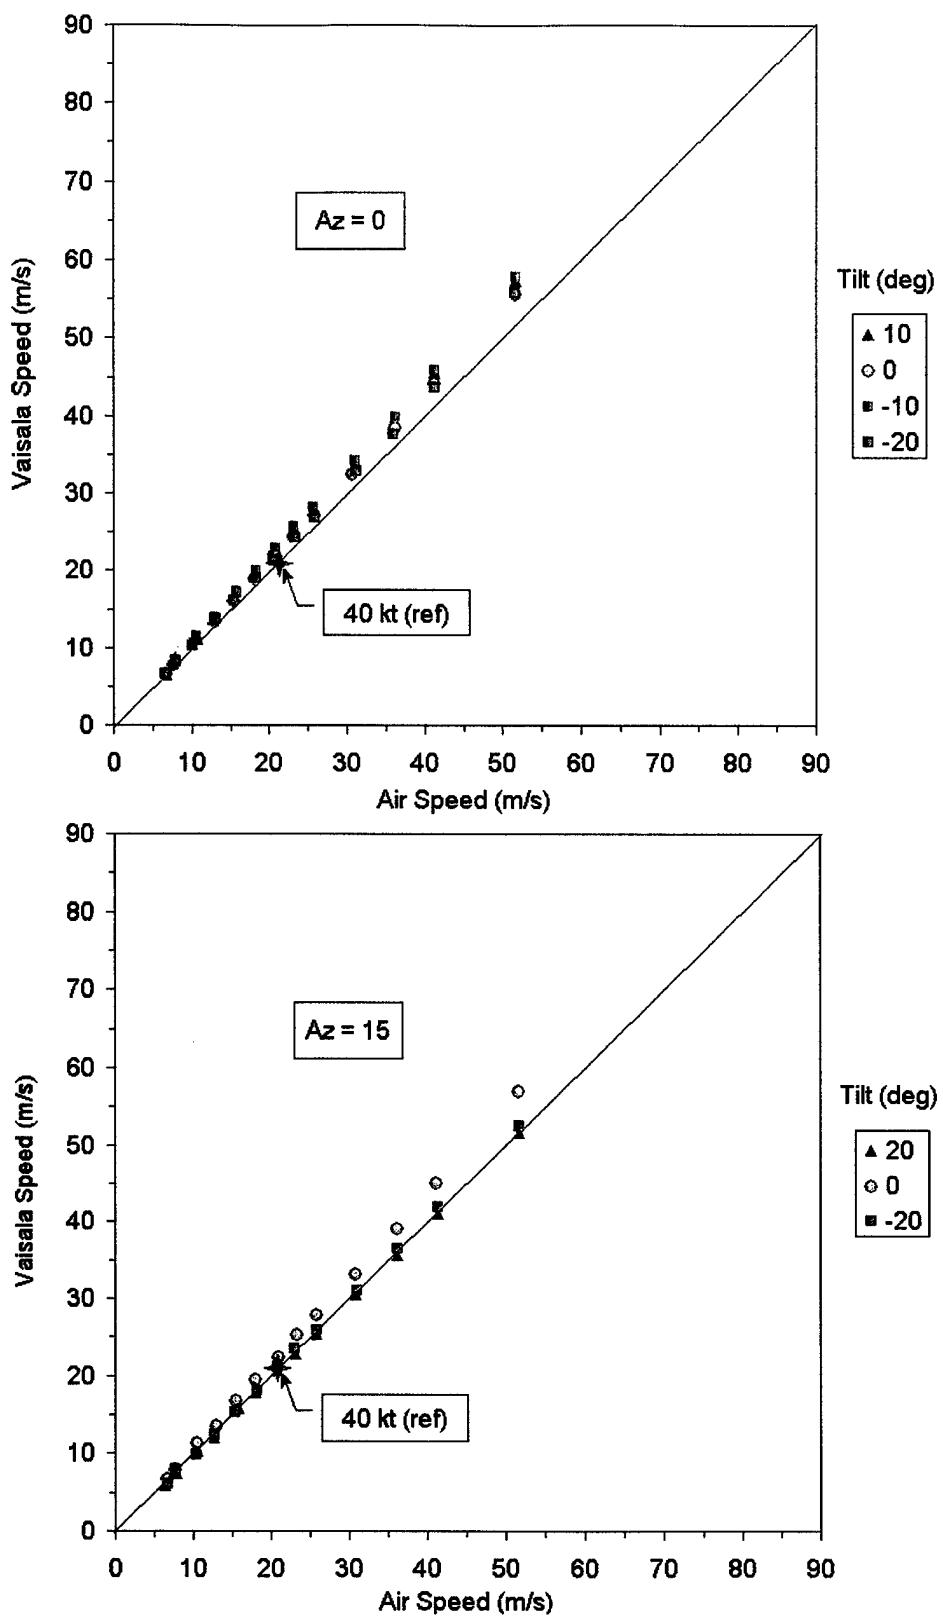
FIGURE 28. WIND TUNNEL ACCURACY RESULTS FOR VAISSALA AT 0 AND 15 DEGREE AZIMUTH ORIENTATIONS

Accuracy results for the Vaisala anemometer according to the various tilts and azimuth orientations are shown in figures 28 and 29.

These results indicate that the Vaisala sensor provides better overall agreement than the mechanical sensors.

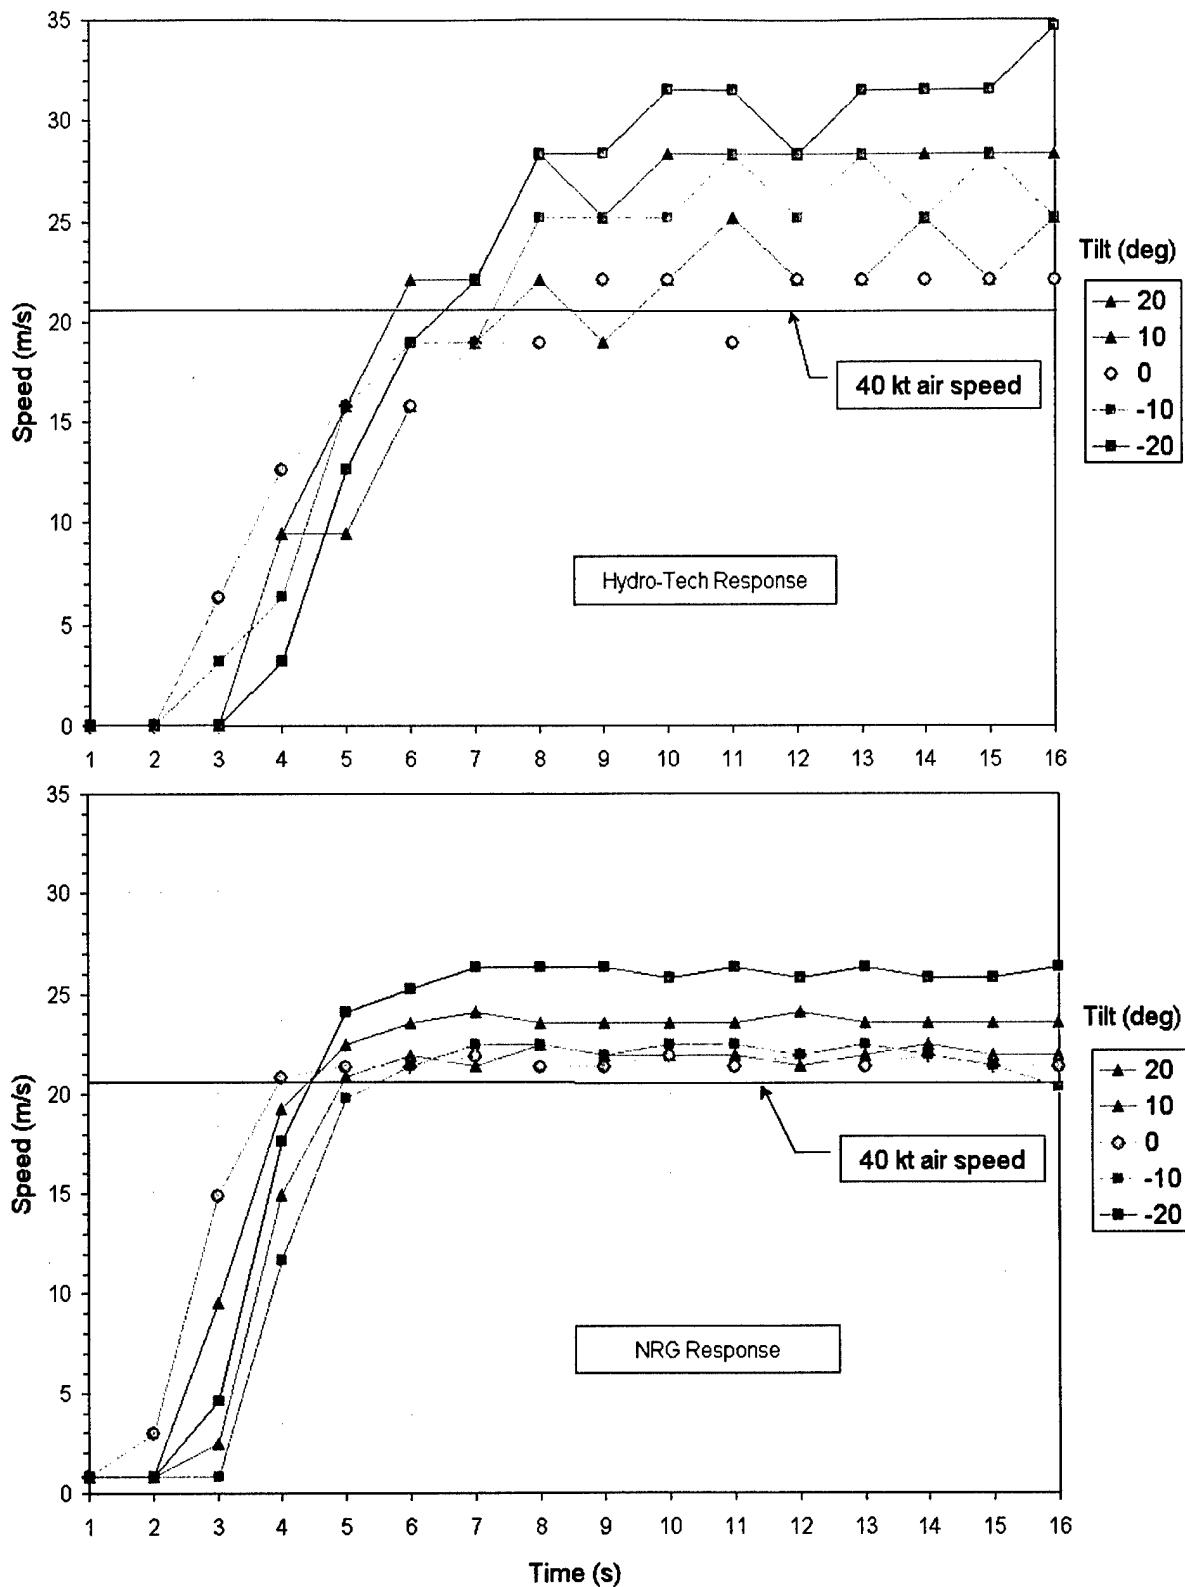
FIGURE 30. WIND TUNNEL RESULTS OF DYNAMIC RESPONSE FOR HYDRO-TECH AND NRG WIND SENSORS

The dynamic response characteristics of the mechanical anemometers are shown in figure 30. The figures show, as expected, that the NRG sensor is more responsive than the more massive Hydro-Tech anemometer. The figures also show the overspeeding that was presented in the previous section.

Time constants were estimated from the response data in two ways. The true time constant was estimated with respect to the actual maximum steady state wind (overspeed wind) that the sensor finally achieved (see figure 30). In addition, time constants were also derived based on the 40 kt wind tunnel air speed as the maximum or final wind reference. The time constants derived from the response tests are displayed in figure 31.

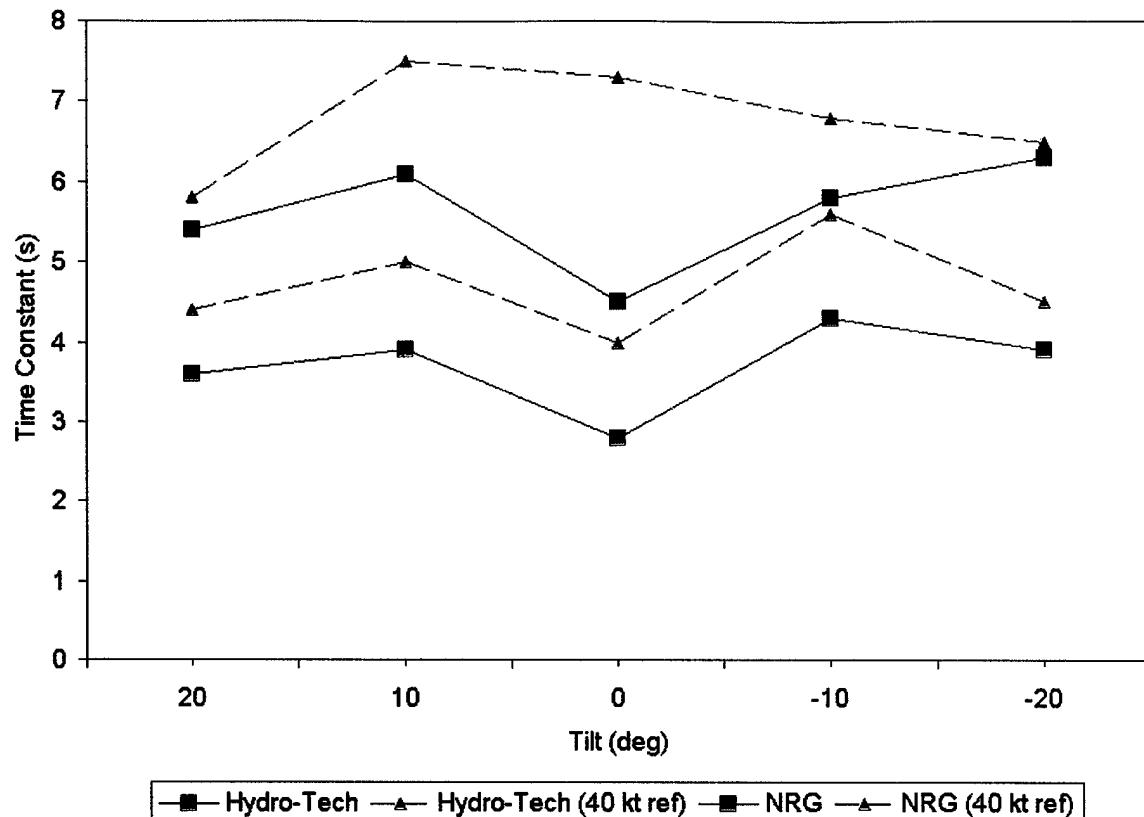
FIGURE 31. TIME CONSTANTS FOR HYDRO-TECH AND NRG WIND SENSORS AT VARIOUS TILTS

The time constants in the figure 31 show that the NRG sensor is more responsive than the Hydro-Tech sensor, and the relative response is slower for off-axis winds.

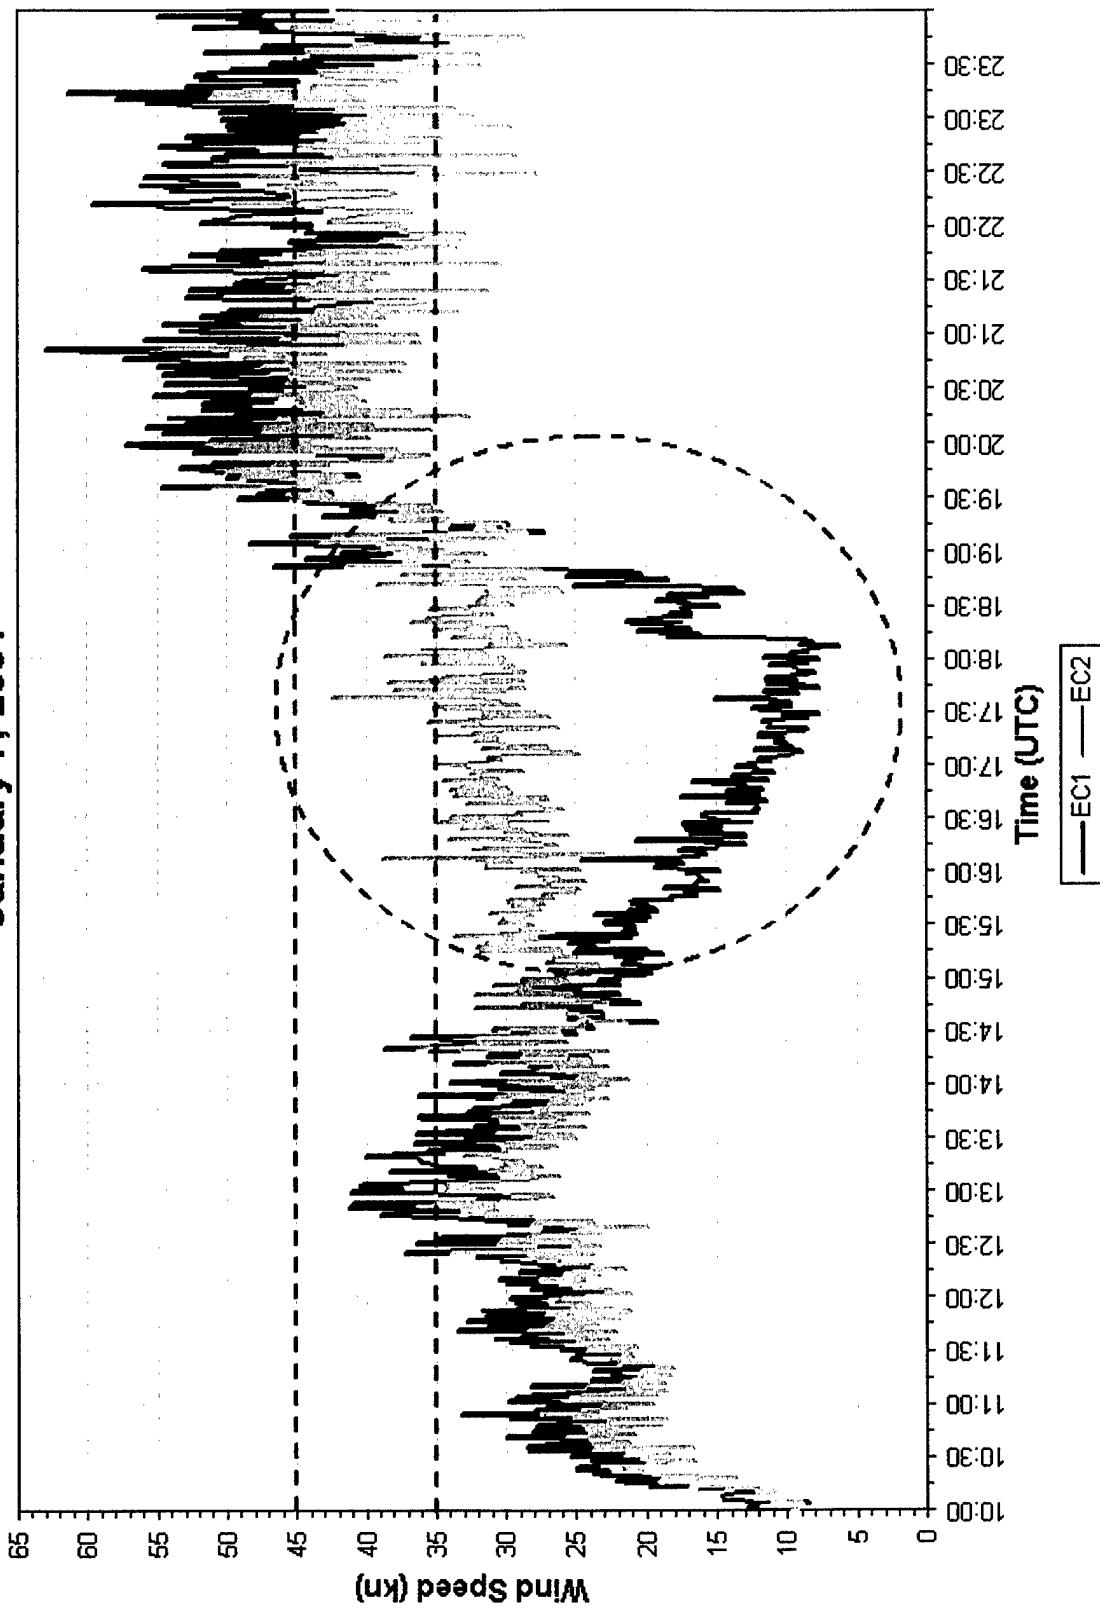
Although no video images of the EC1 sensors were collected, inspection of the data revealed that these sensors were affected by icing in more cases than the EC2 sensors. It is suspected that this was due to the location of the sensors on the tower and the greater exposure of these sensors to southeast wind flows than the EC2 sensors. Performance of the EC1 and Test Hydro-Tech rotor anemometers are shown for the 5 southeast flow cases shown in figures 50 through 54. The figures show prolonged periods of low wind speed readings as compared to the other sensors. An interesting aspect of these cases shows that the degradation in performance is gradual, and there are no particular characteristics in the traces that indicate obvious sensor degradation except for the comparison with the other sensors.

FIGURE 50. COMPARISON OF EC1 AND EC2 WIND SPEEDS

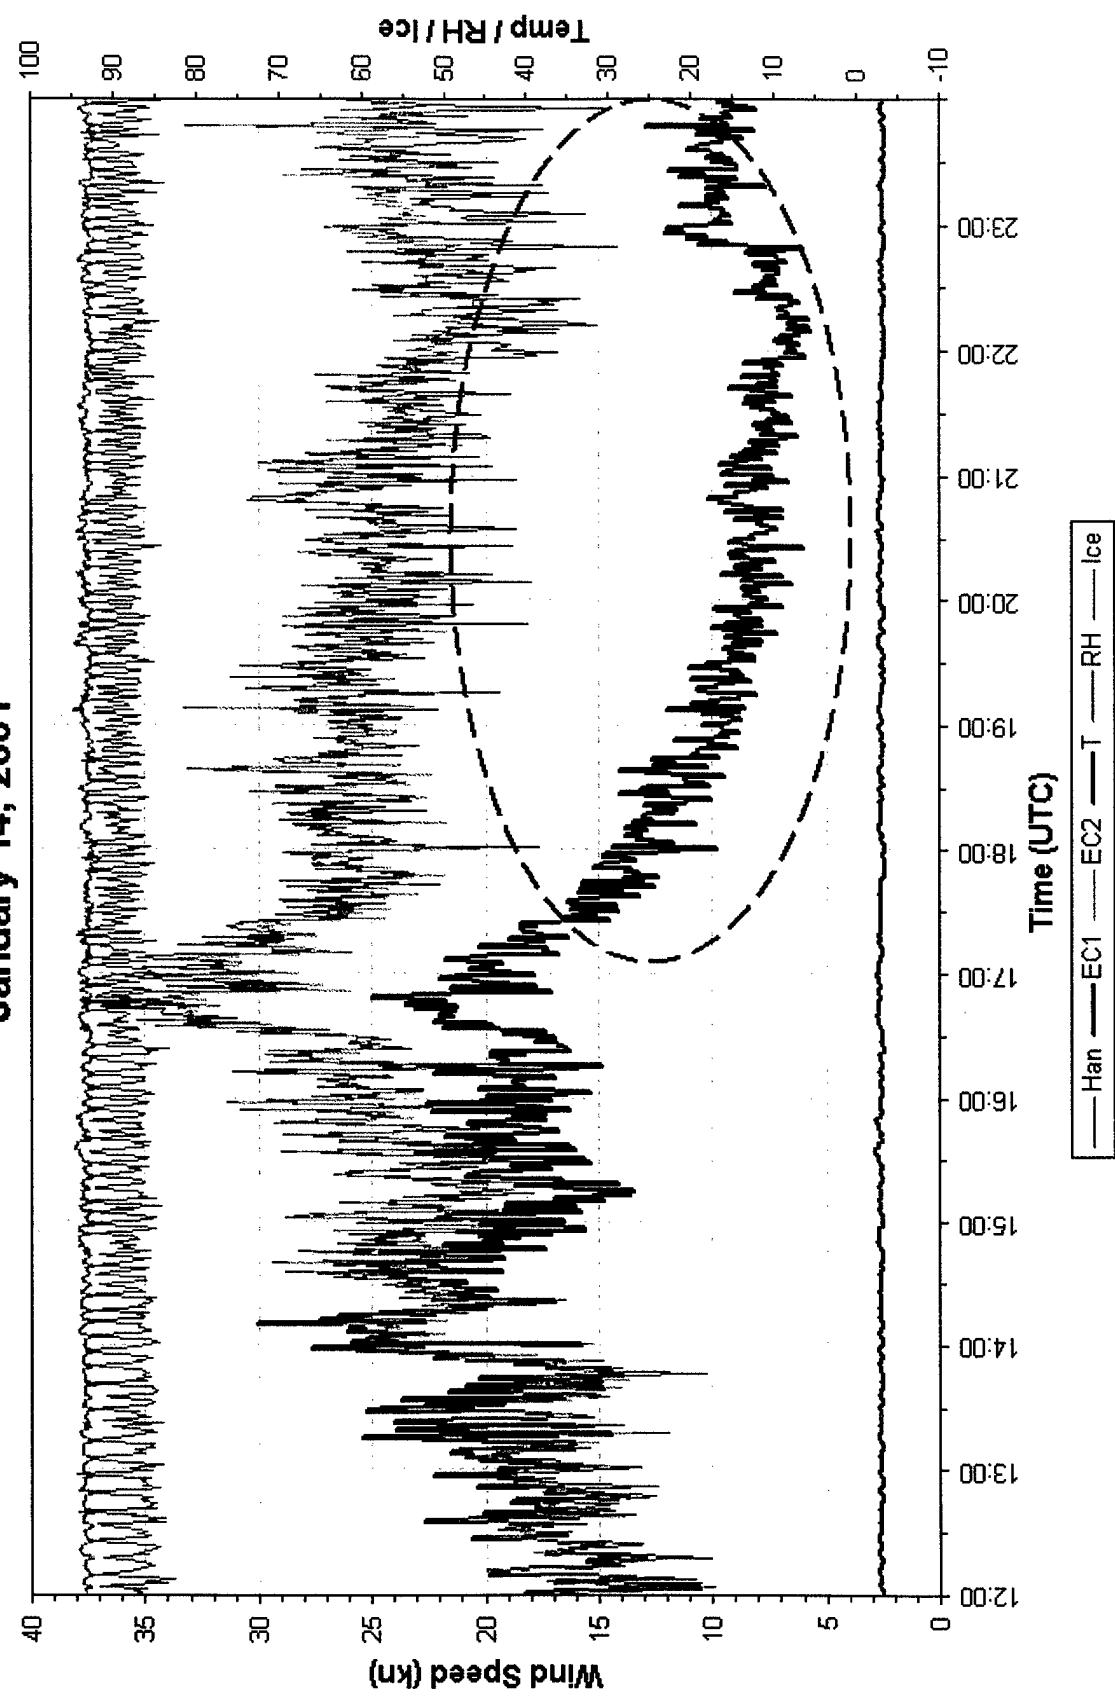
FIGURE 51. COMPARISON OF EC1 WIND SPEED AGAINST EC2 AND VAISSALA WIND SPEEDS

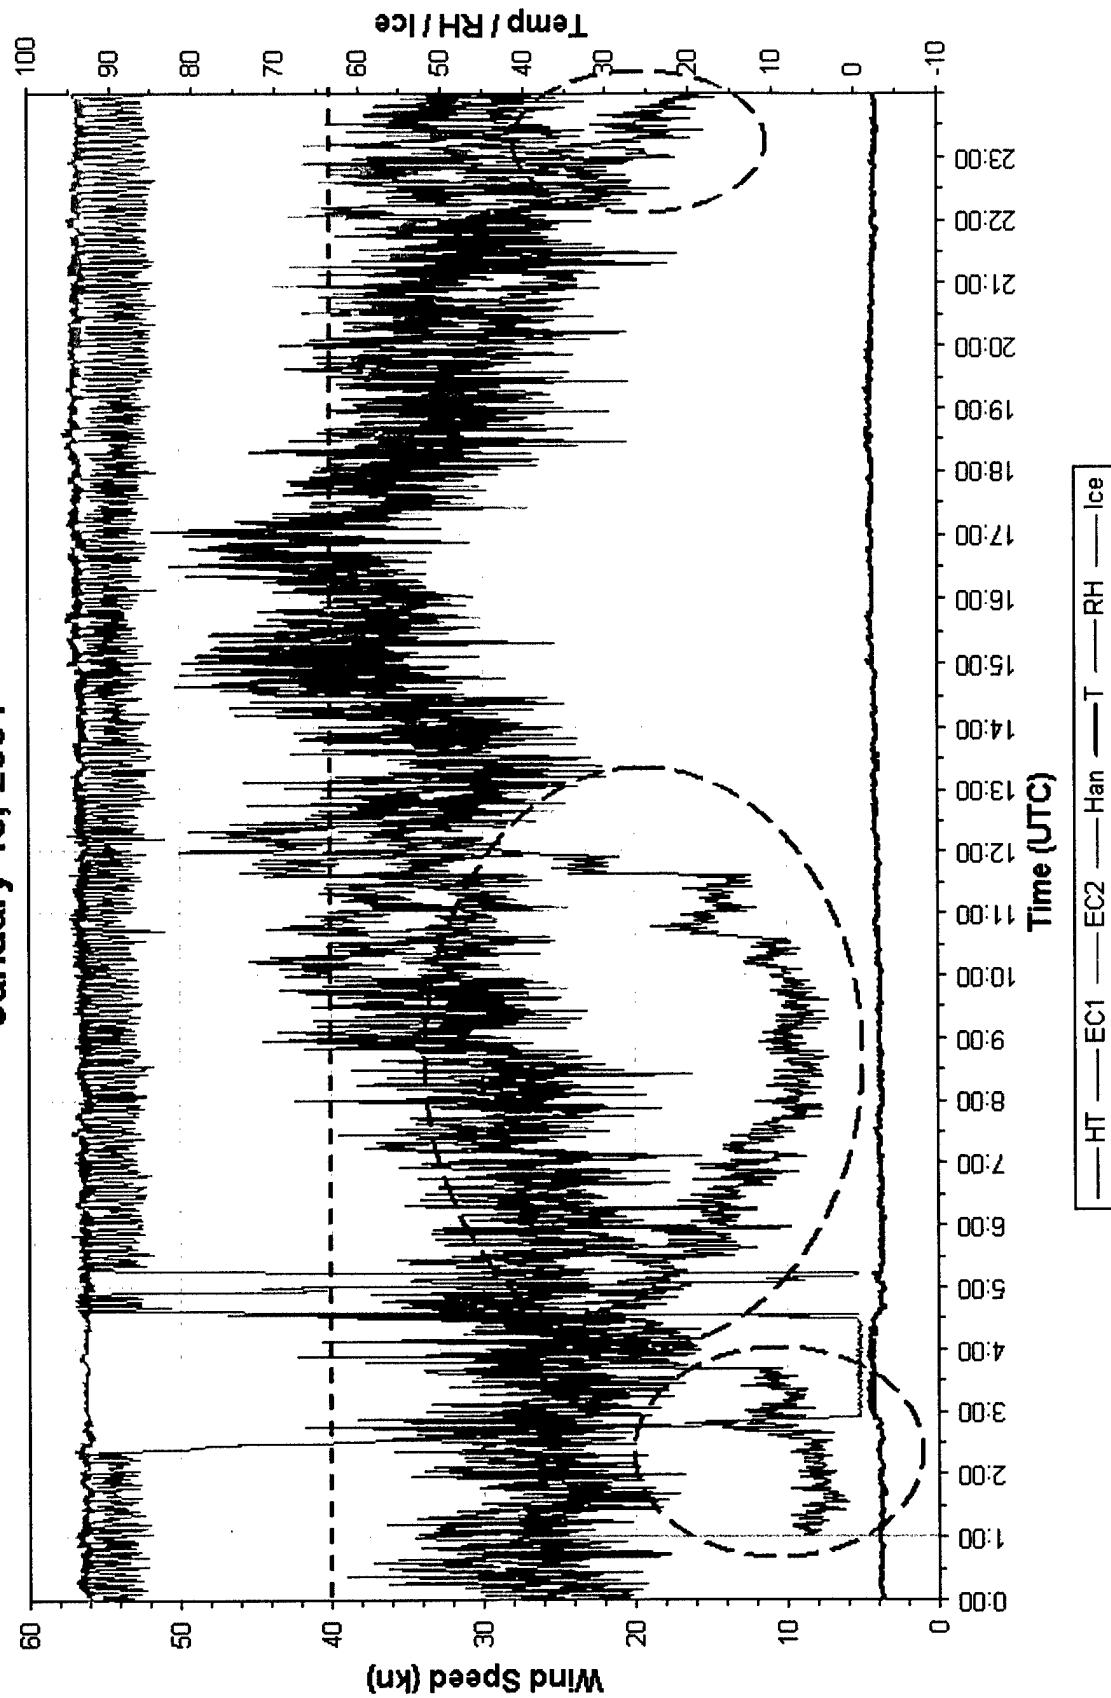
January 15, 2001

FIGURE 52. COMPARISON OF EC1 WIND SPEEDS DURING AN ICING EVENT

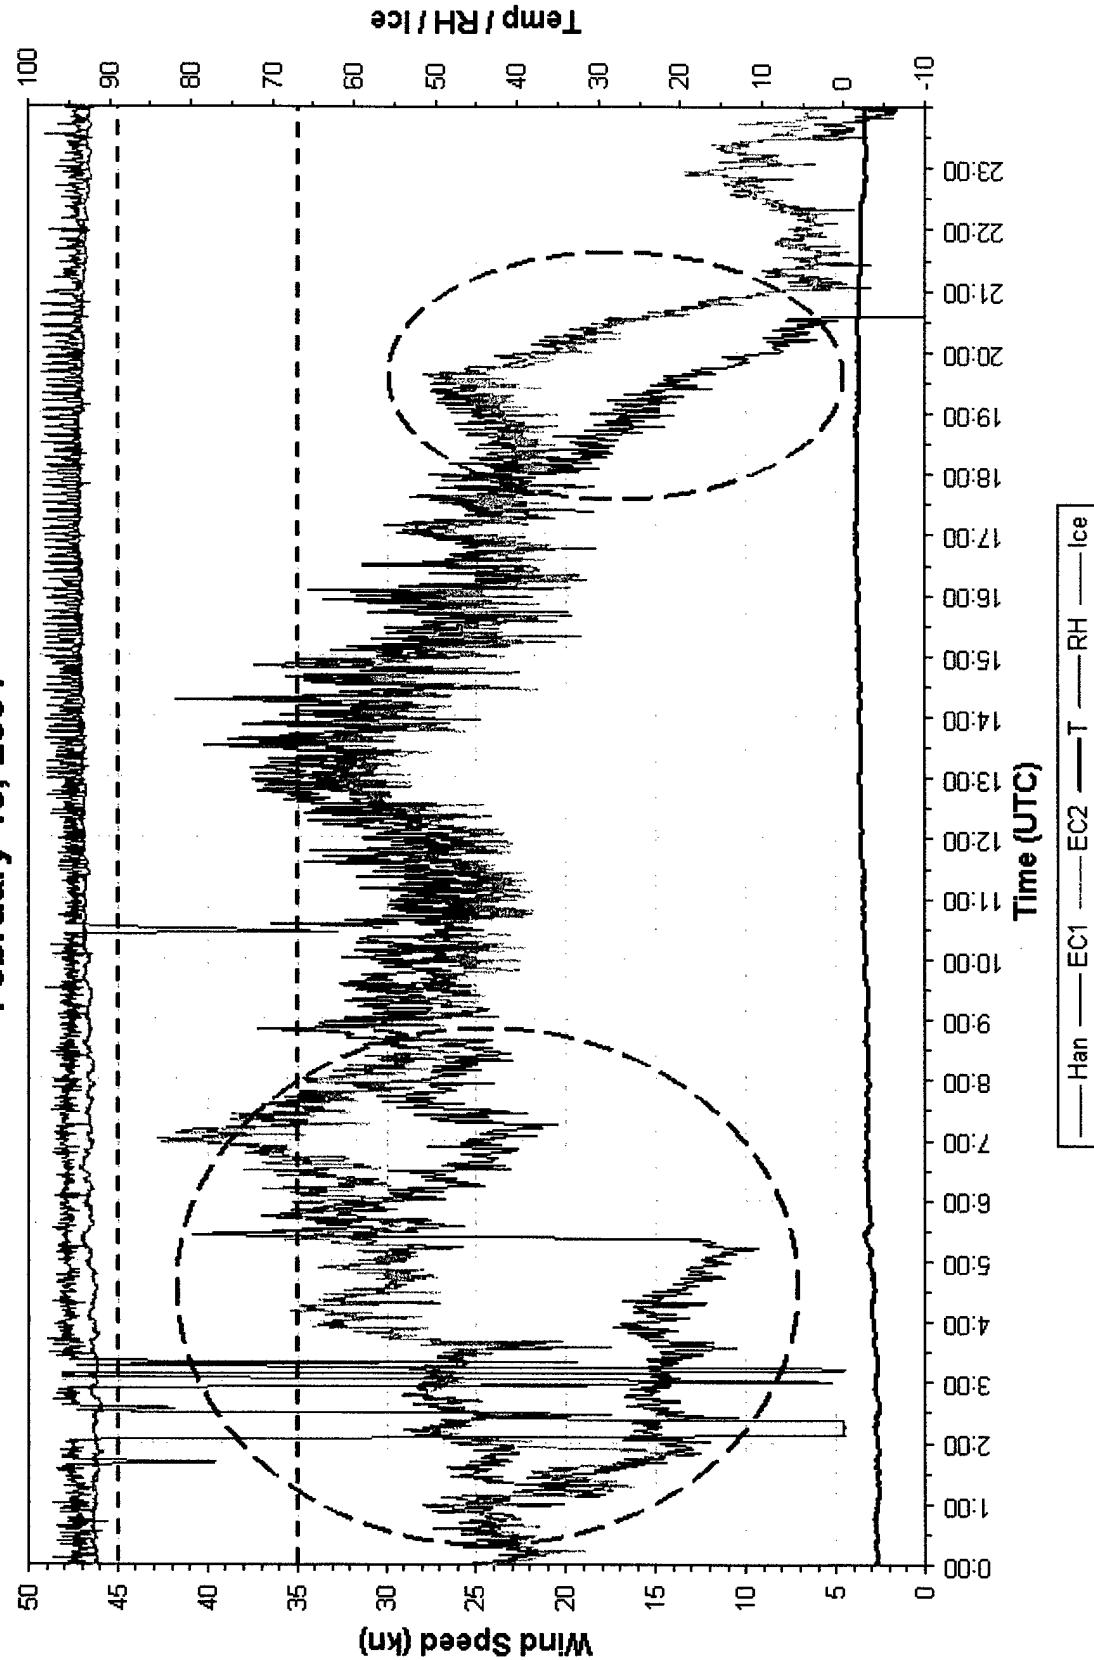
February 13, 2001

FIGURE 53. DEGRADED EC1 ROTOR PERFORMANCE DURING AN ICING EVENT

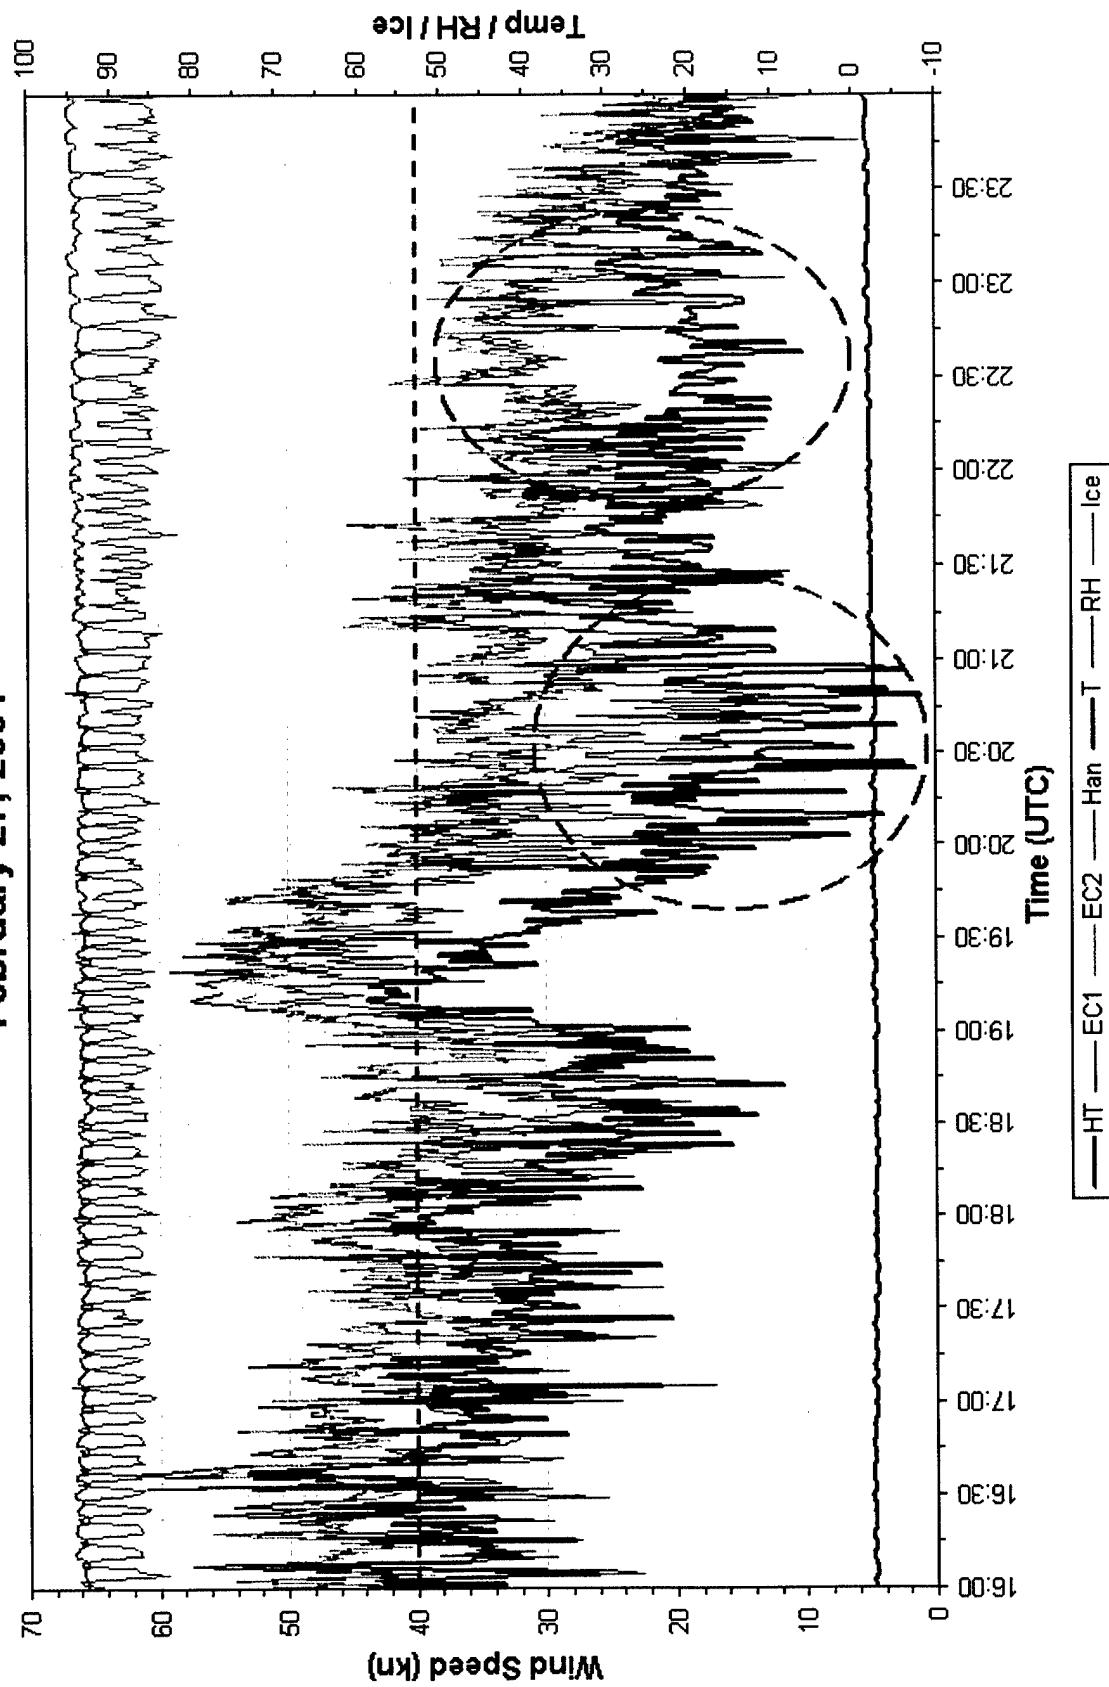
February 27, 2001

FIGURE 54. TEST HYDRO-TECH ROTOR FAILURE DURING AN ICING EVENT

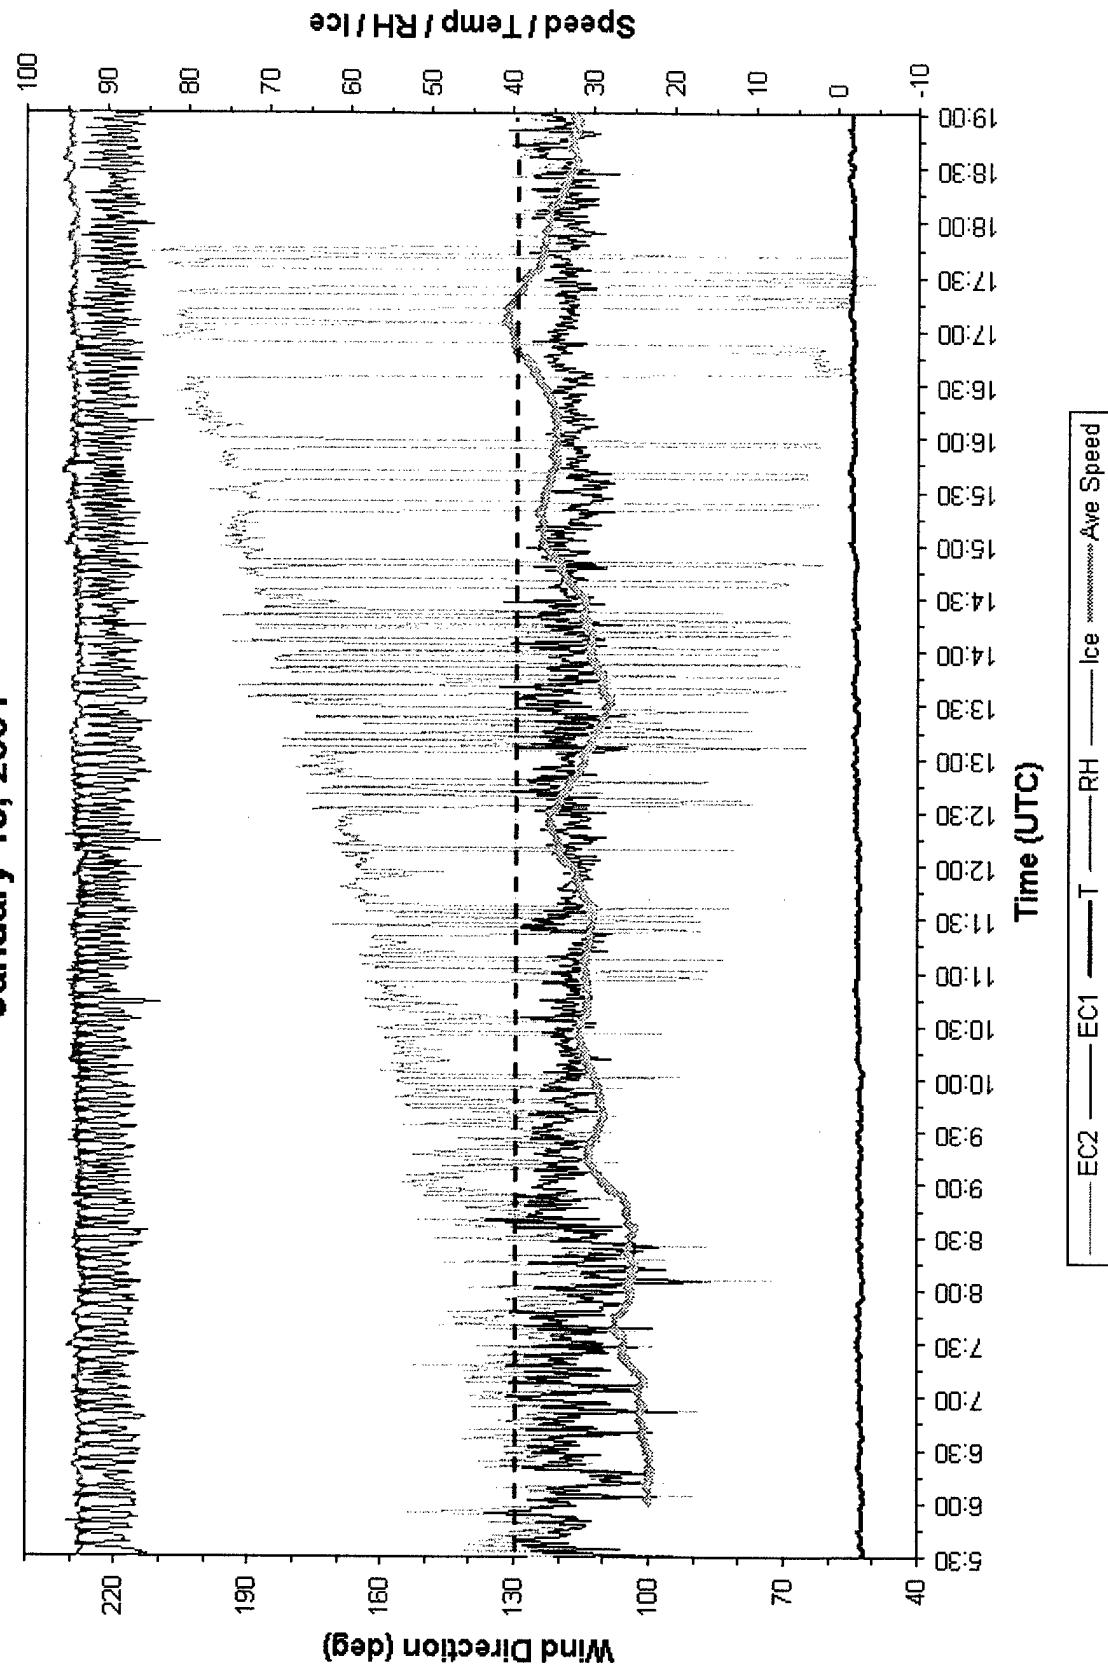
January 15, 2001

FIGURE 55. EC2 DIRECTION VANE FAILURE DURING AN ICING EVENT

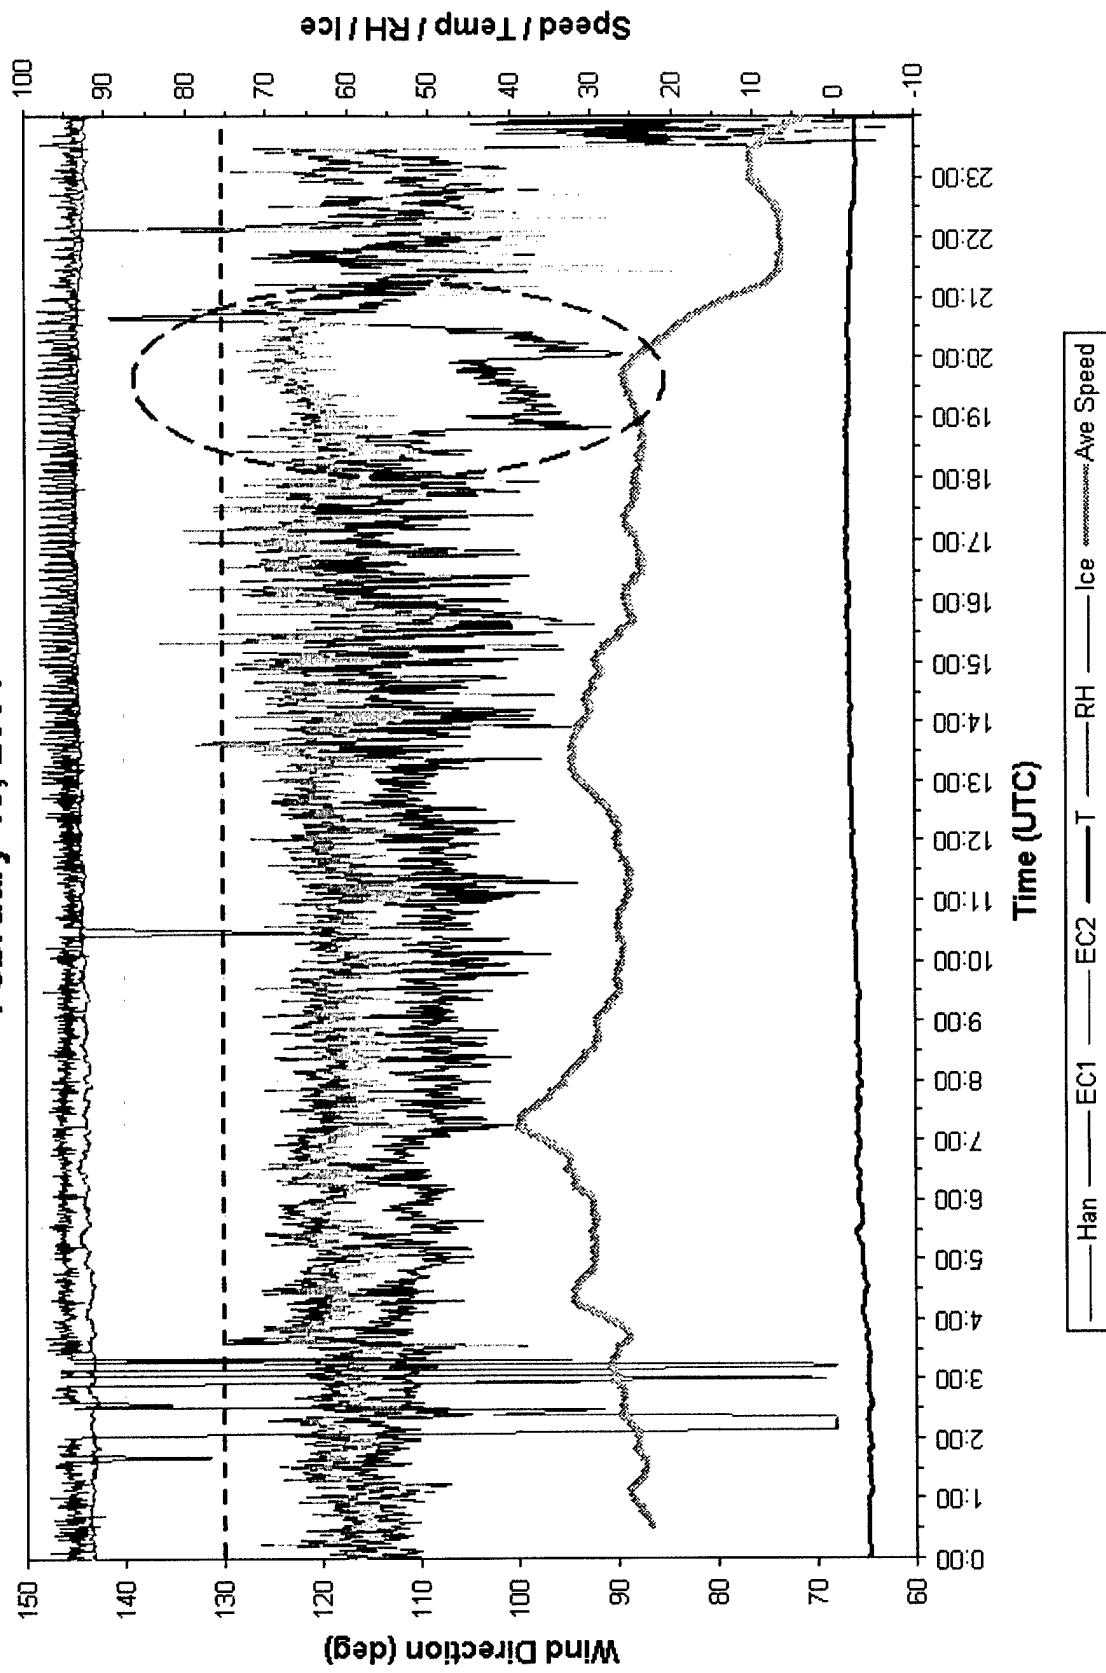
February 13, 2001

FIGURE 56. EC1 DIRECTION VANE FAILURE DURING AN ICING EVENT

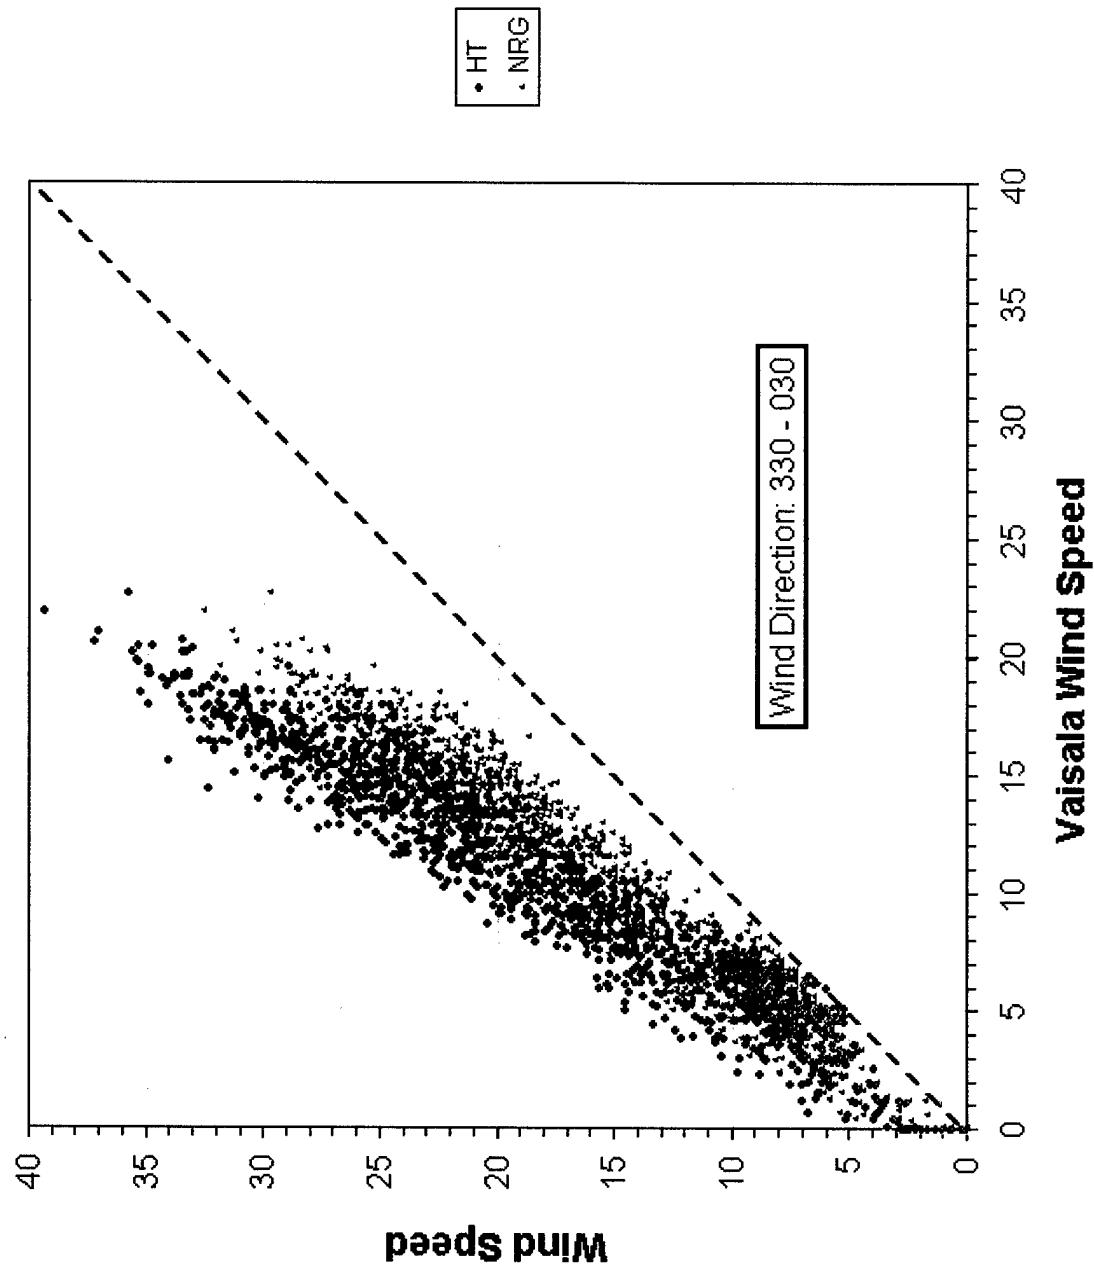
Performance of the sensor was found to be consistent with data from the wind tunnel tests and results from the MWO study. Typical cases showing a comparison of wind speed against the Vaisala anemometer is provided in figures 57 through 60. Due to the inertia of the ruggedized sensor, the observed overspeeding and a low starting threshold was expected. The overspeeding indicated in the figure is particularly pronounced for northerly winds and is possibly exacerbated by the upslope winds at Eagle Crest in this direction. The off-axis overspeed response inherent to the sensor was also noted in the wind tunnel tests.

FIGURE 57. WIND SPEED DISTRIBUTION FOR NORTH WIND

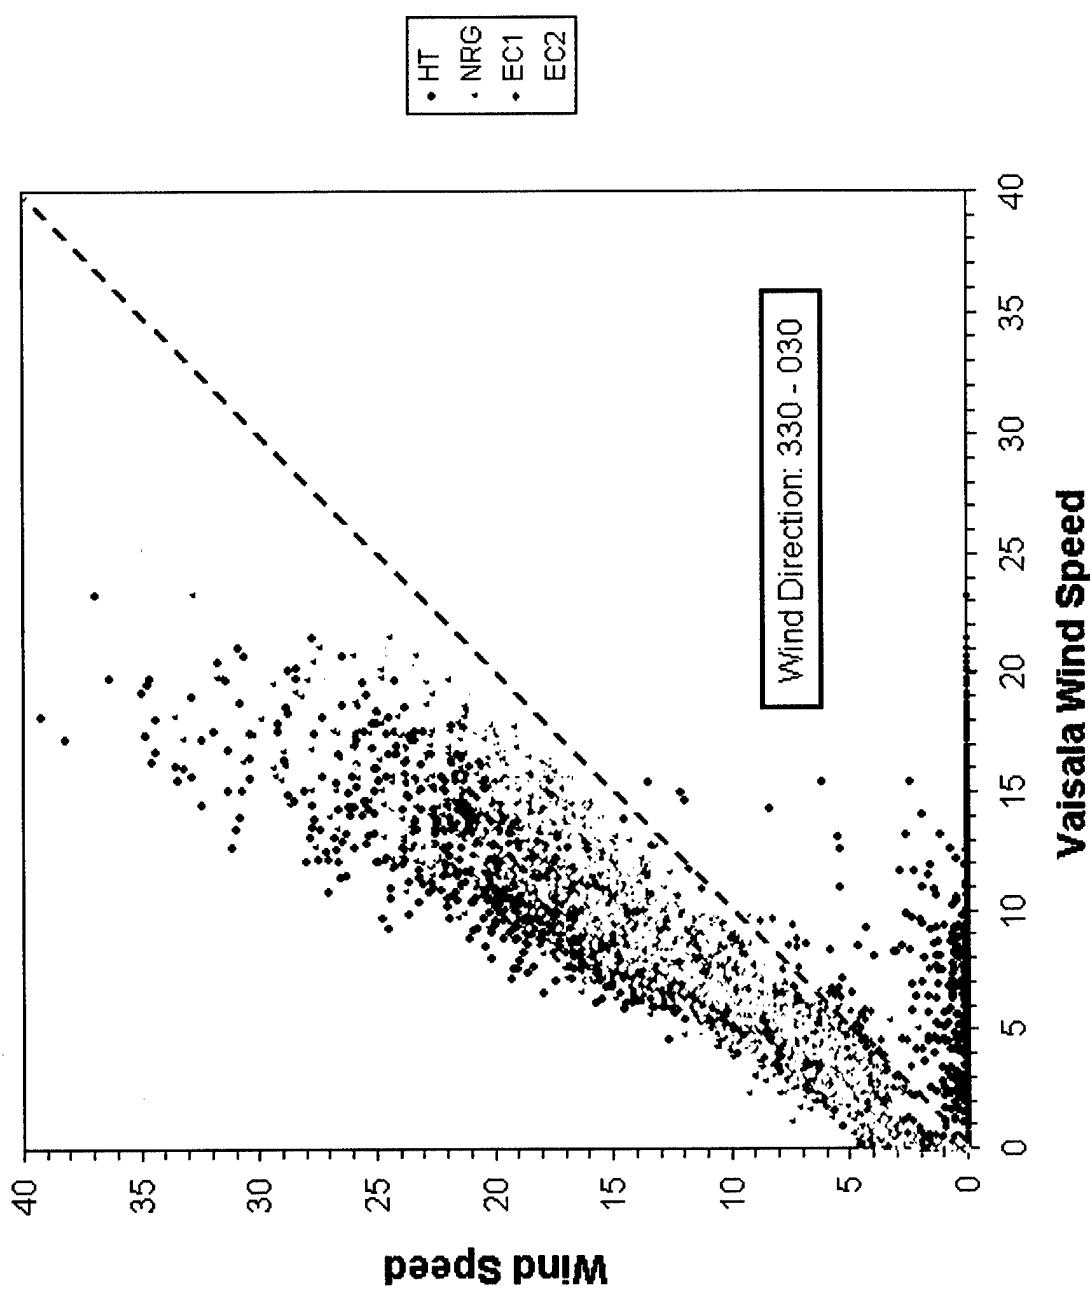
FIGURE 58. WIND SPEED DISTRIBUTION FOR NORTH WIND
